# The Owner's Guide to Piano Repair

## Focus On: Refelting the Keybed

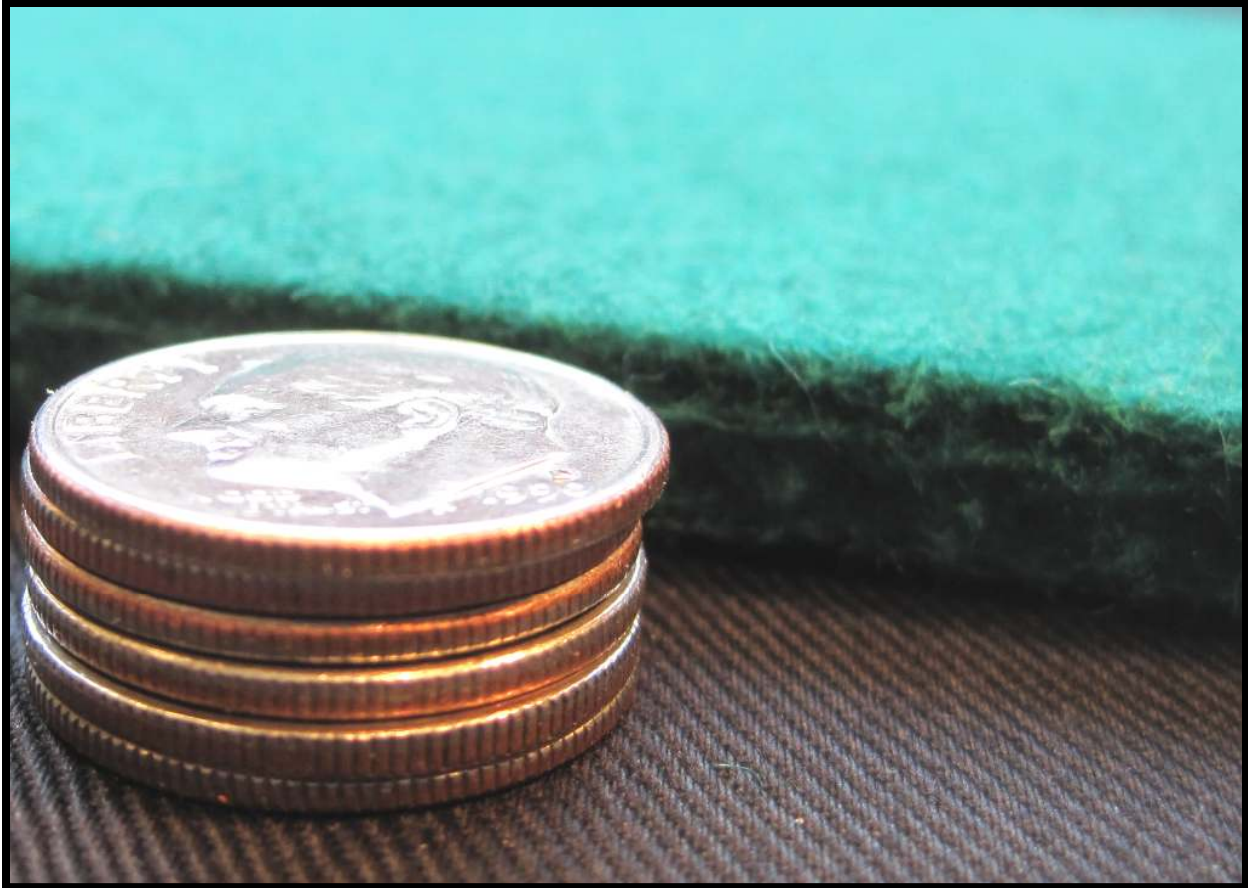
*The thickness of heavy backrail cloth equals that of six dimes.*

Very much so. As illustrated in the photo above, the felt used for backrail cloth (as well as balance rail and front rail punchings) is a very thick, dense felt that is designed to stand up to decades of constant use.

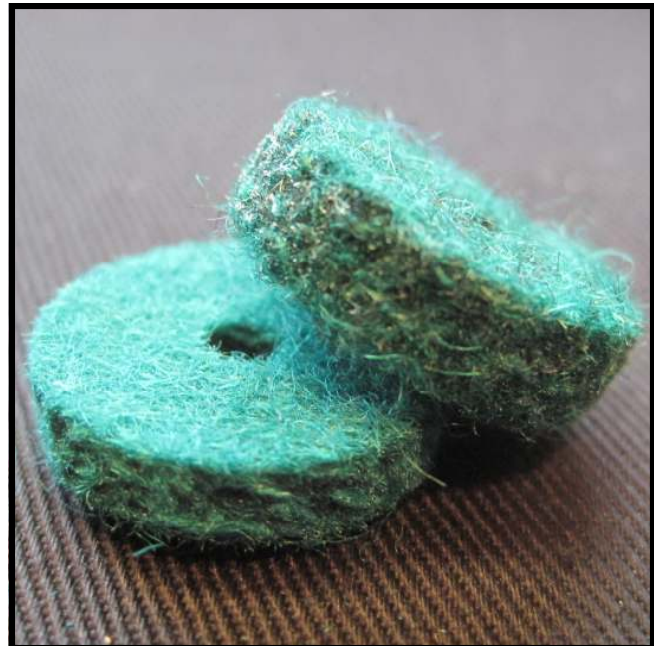
*Thinnest and thickest front rail punchings.*
