# The Piano Owner's Heads-Up Guide to Important Piano Maintenance

## Focus On: Splicing Broken Grand Hammer Shanks

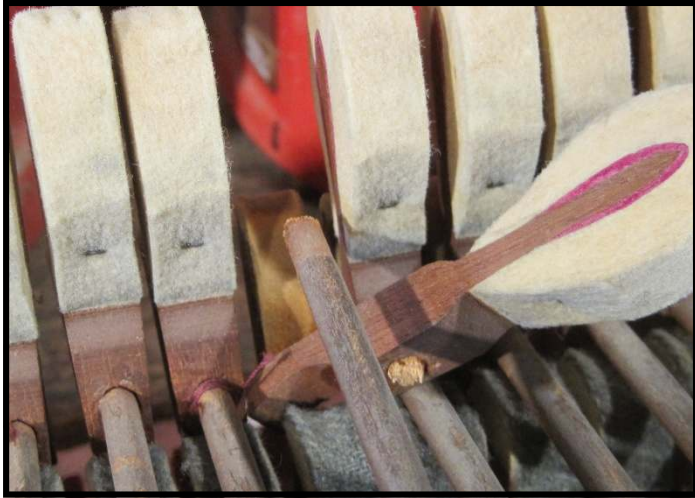
**Grand piano hammer shanks are subjected to continual stress as the piano is being played, and upon occasion will break, usually in a section of the keyboard that is used most frequently.** When this happens, as shown in the photo above, at least one note (sometimes more) quit working suddenly, and a repair is needed. **Your piano has broken shank/s needing repair.**

When the break in the shank is a long one (think of a pencil that has split apart) it may be possible to join the two halves together and reglue them. However, if the end of the break is more or less blunt, it is necessary to either replace the shank with a new one, or repair it with a splice.

Splicing the shank is an option which gets the piano up and running again, and is useful especially in situations where replacements for the old flanges are either not available, or need to be specially ordered. Done well, a repair splice will last for as long as needed.

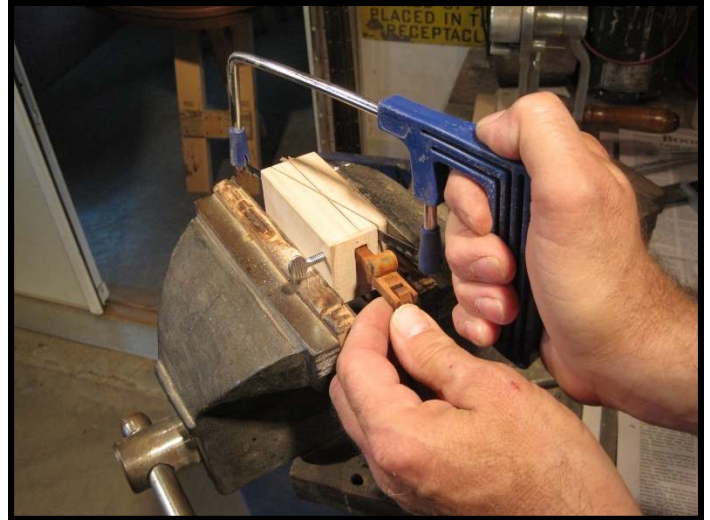
*Special sawing jig required.*

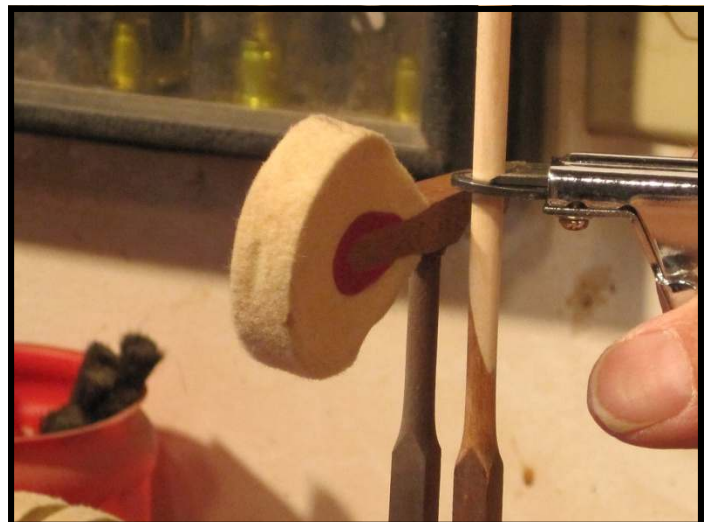
*Newly spiced shank being cut to length.*
